INVESTIGATION INTO THE MECHANISM OF DEGRADATION OF SOLAR CELLS WITH SILVER-TITANIUM CONTACTS

D2-126194-1

FIRST QUARTERLY PERIODIC PROGRESS REPORT

THE BOEING COMPANY, AEROSPACE GROUP, KENT FACILITY
SEATTLE, WASHINGTON

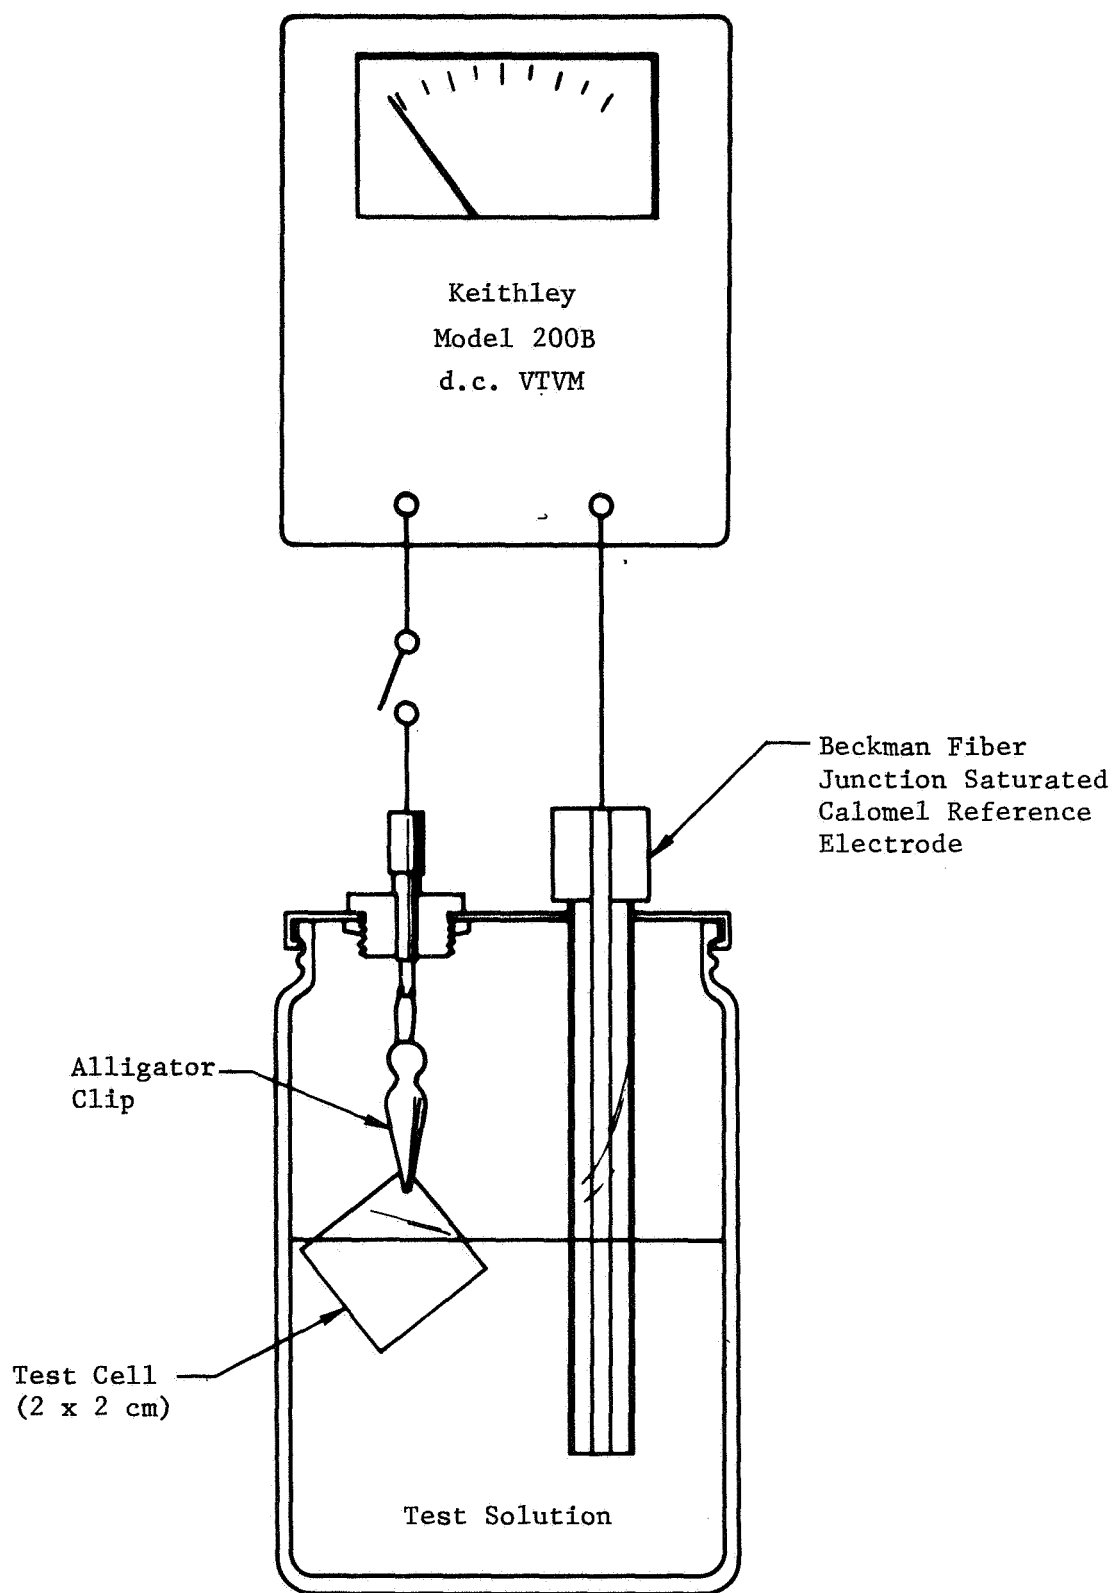
Figure 13: REST POTENTIAL TEST SETUP

Rest potential is the open circuit equilibrium potential which an electrochemical cell exhibits when its electrodes are in contact with the electrolyte. Rest potential versus time measurements, in addition to potentiostatic measurements, are being used to characterize the corrosion in the solar-cell contacts. The instrumentation required is not elaborate and several cells can be tested at the same time. Rest potentials are measured with a high impedance voltmeter (KEITHLEY, Model 200B) against a SCE reference electrode (Figure 13).

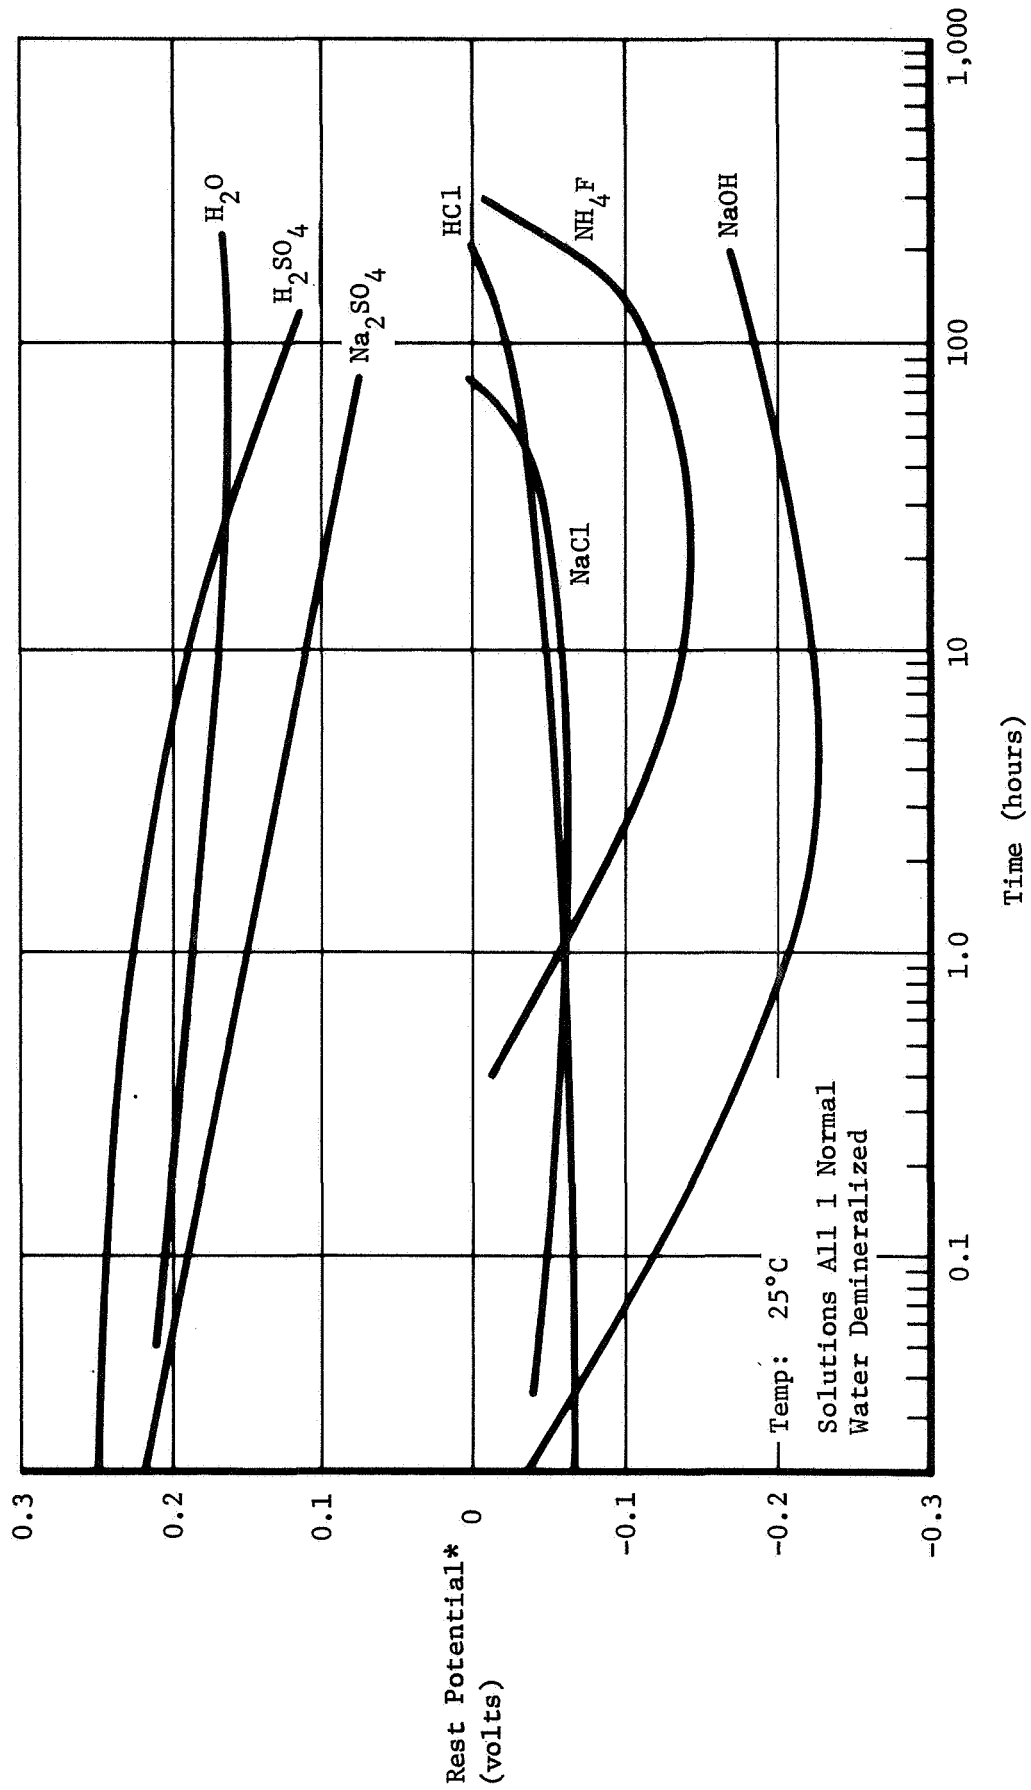
*With Reference to Saturated Calomel Electrode

Figure 14: REST POTENTIAL* VERSUS TIME

Figure 14 shows rest potentials as a function of time. These data, when considered with other solar-cell power degradation measurements, show that the negative rest potentials with respect to the SCE are associated with rapid degradation at room temperature and blistering. Of particular interest are the curves for the halides, because mass spectrographic analyses have shown a surprising amount of fluorides present on the solar cell surface (See Section 3.5, Physical Measurements). The fluorides seem to be a residue of the etching and cleaning processes used in the manufacture of the solar cells.

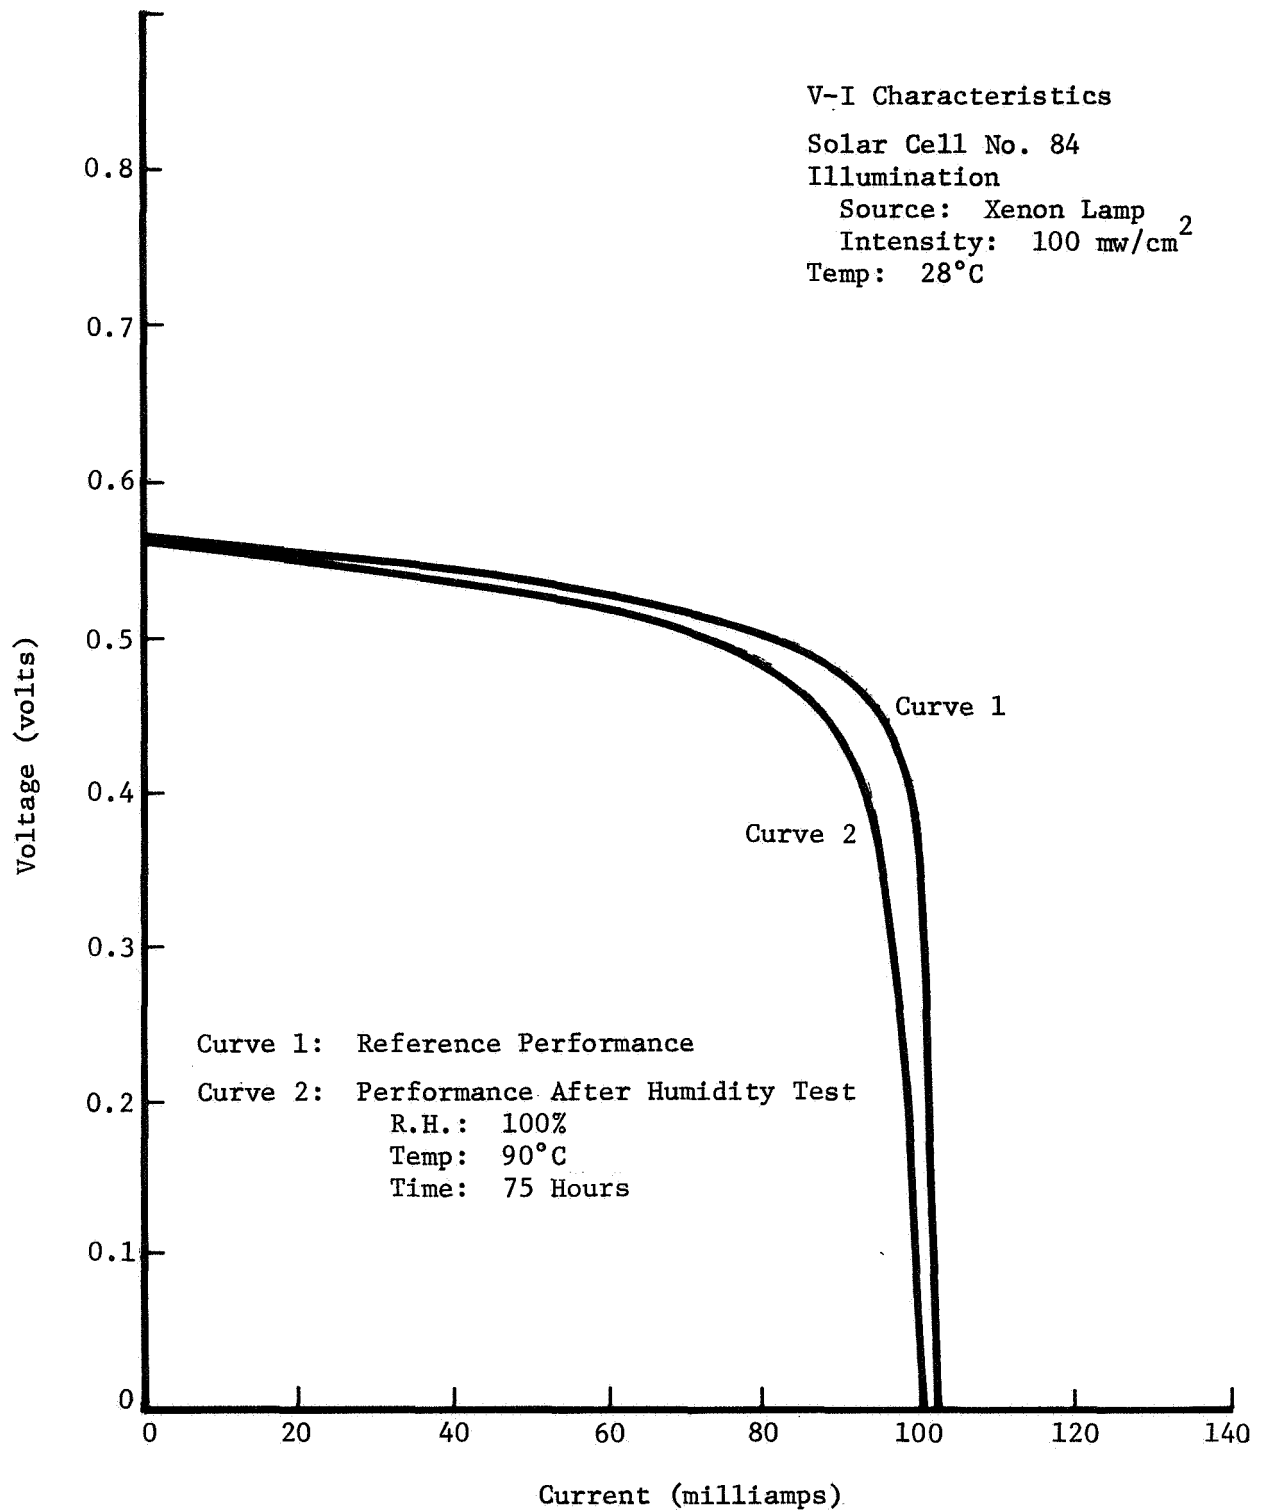
Figure 15: PERFORMANCE DEGRADATION FROM A HUMID ATMOSPHERE

Chloride and other halogens ions are a possible cause of titanium corrosion. Chloride ions break down passivity in metals such as (Fe and Cr) by penetrating oxide layers (Ref. 8). The reaction is local rather than over the entire surface, and preferred sites are determined by variations in the oxide film. The hypothesis that halogens promote degradation was tested by storing solar cells in an atmosphere of water and HCl. The solar cells were above the water in a covered container having a relative humidity of 100 percent in a 90°C oven. After 75 hours the cell exhibited blisters and the V-I curves indicated that degradation had occurred. Figure 15 shows typical V-I curves before and after storage. A photograph of the degraded cell is shown in Figure 16.

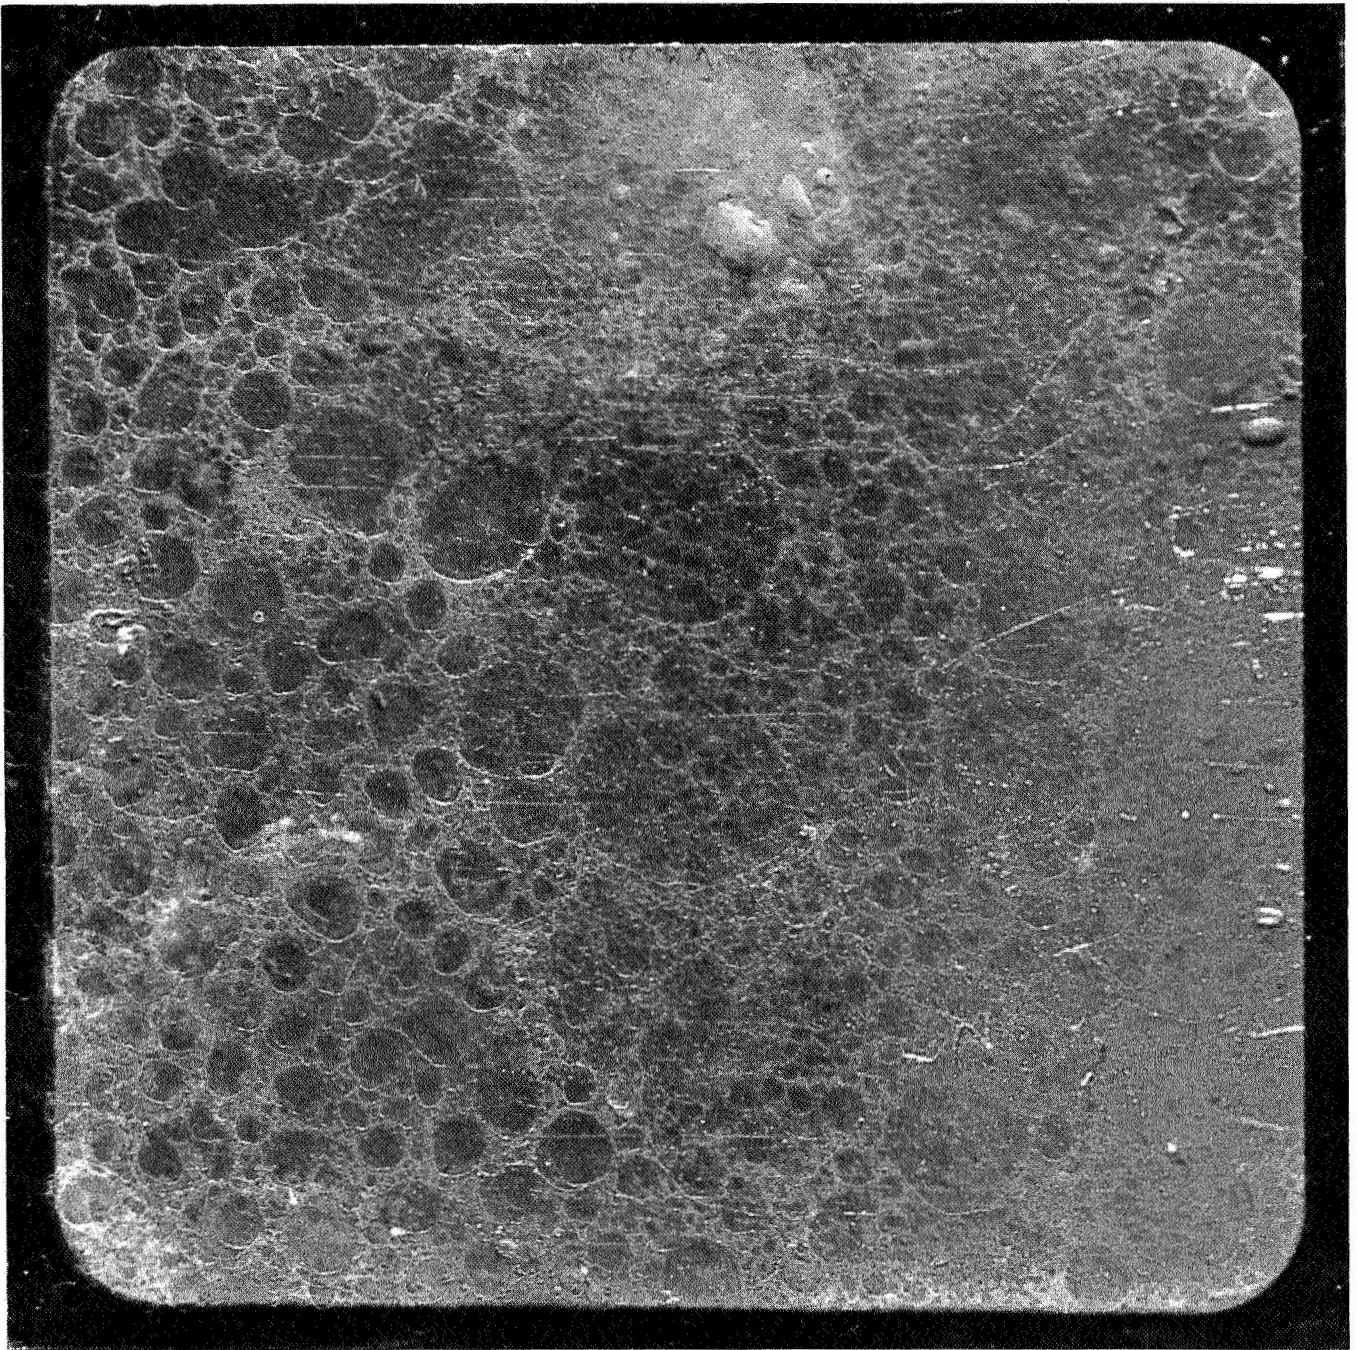
Figure 16: SOLAR CELL AFTER 75 HOURS IN HUMID ATMOSPHERE

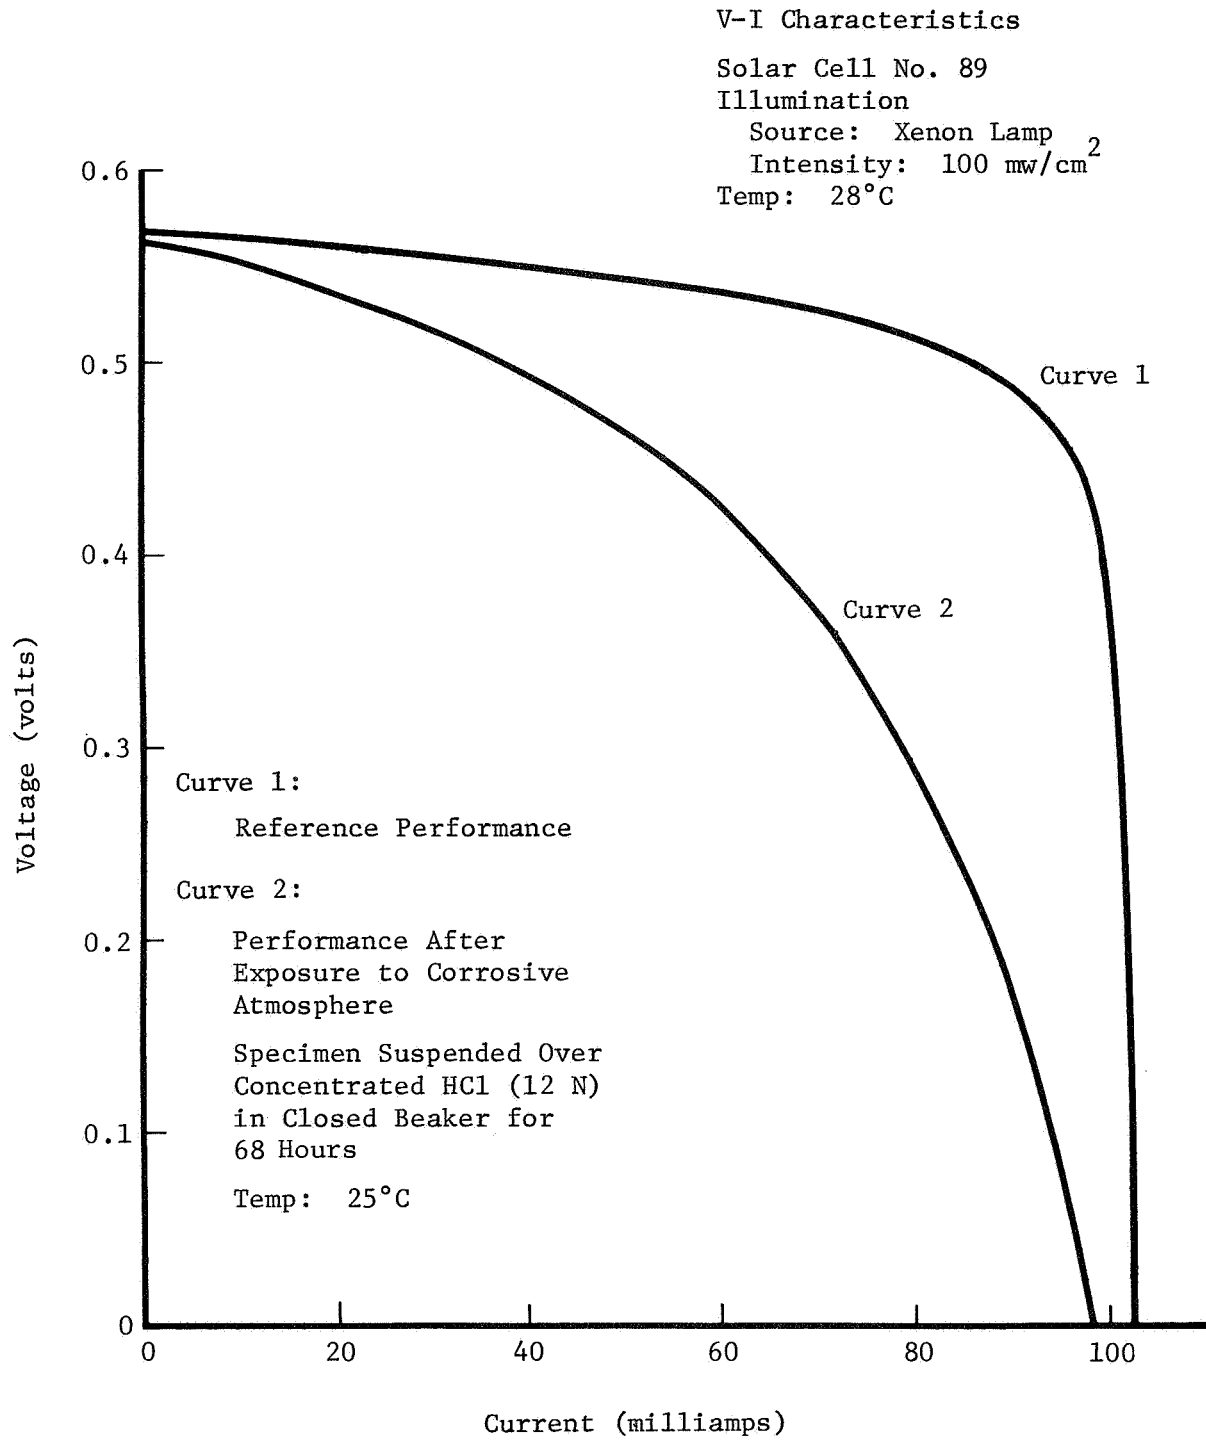
Figure 17: PERFORMANCE DEGRADATION FROM CORROSIVE HCl ATMOSPHERE

Blisters similar to those obtained in the water humidity test became prominent after 6.5 hours of exposure when a solar cell was suspended over a concentrated 12-normal solution of HCl at room temperature. Shown in Figure 17 are V-I curves taken before exposure and after 68 hours of exposure to this HCl atmosphere. The degradation was severe (Figure 19). The corresponding power curve is shown in Figure 18. 3M found similar results with similar tests (Ref. 9).

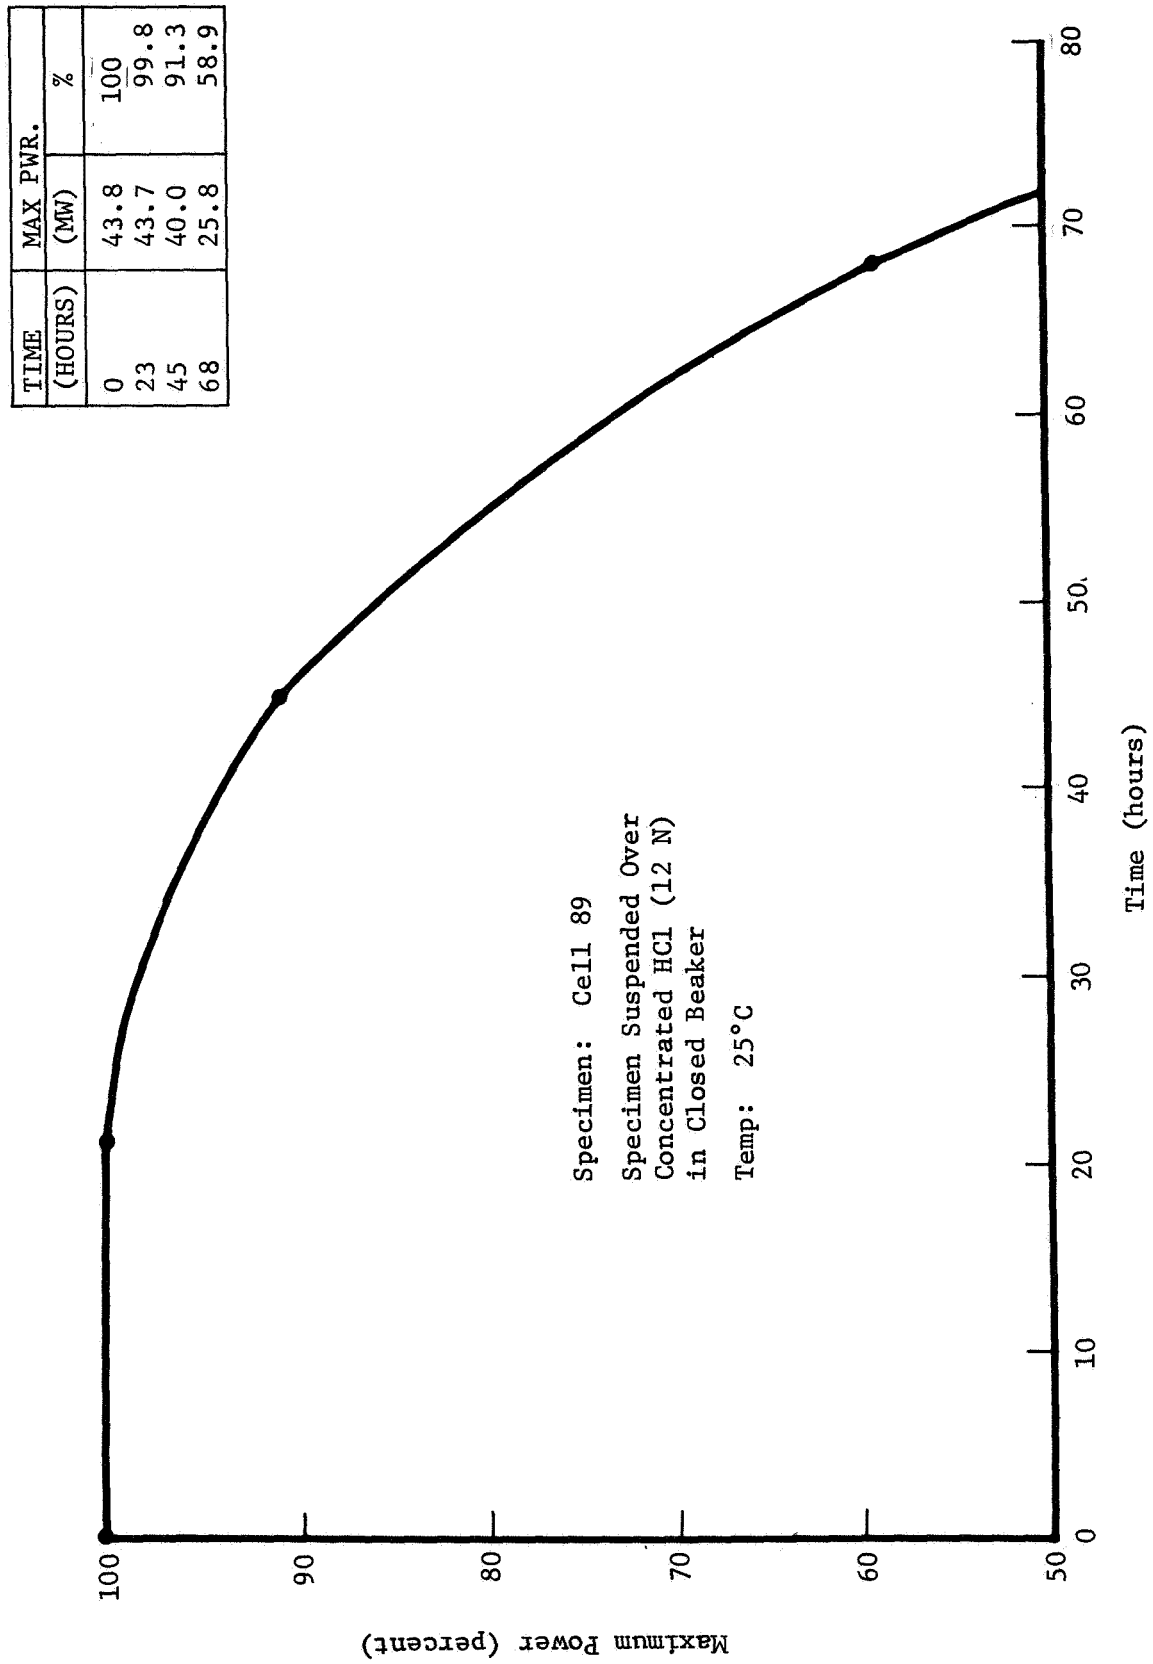
Figure 18: PERFORMANCE DEGRADATION RATE FROM A CORROSIVE HCl ATMOSPHERE

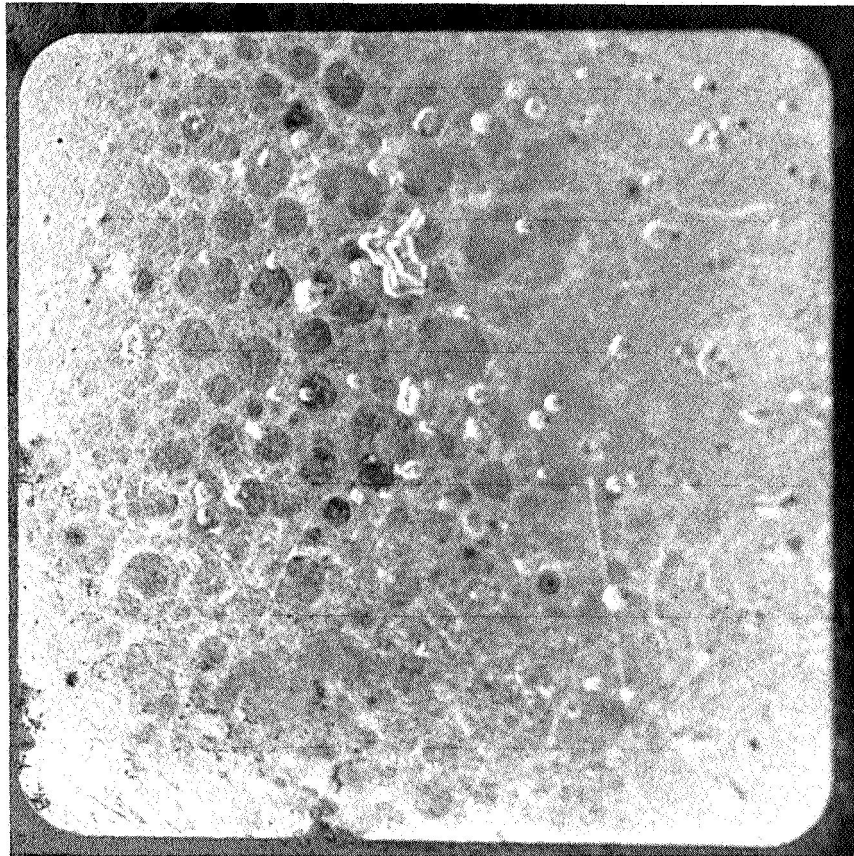
Figure 19: SOLAR CELL AFTER 68 HOURS IN HCl ATMOSPHERE

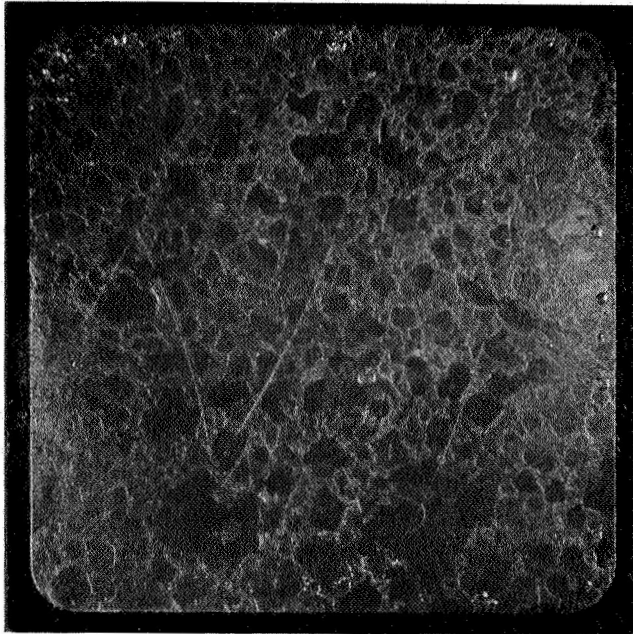
Figure 20: BLISTERED AREA, 4X MAGNIFICATION

Blisters on solar cells are big enough to be easily seen. Figure 20 shows the appearance of the blistered surface and what appears to be a large grain size. Examination at a higher magnification shows a series of plateaus with no true grain boundary (Figures 21 and 22). Figure 22 in particular shows a continuous surface pattern through a ridge that resembles a grain boundary at low magnification. Blisters appear to be located at these plateau boundaries.

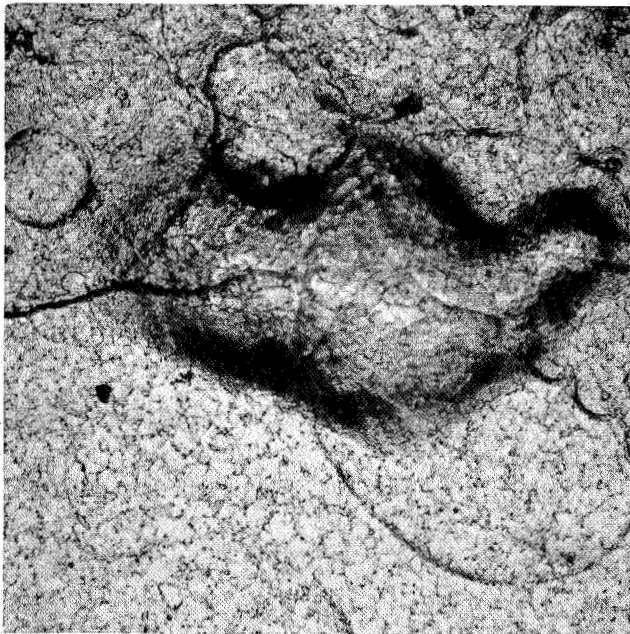
Figure 21: BLISTERED AREA, 200X MAGNIFICATION

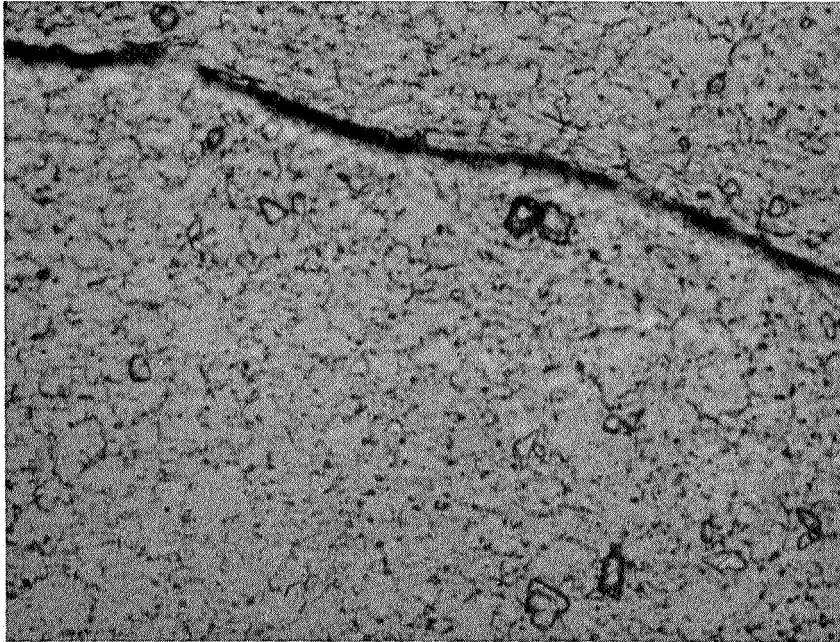
Figure 22: CELL SURFACE, 500X MAGNIFICATION

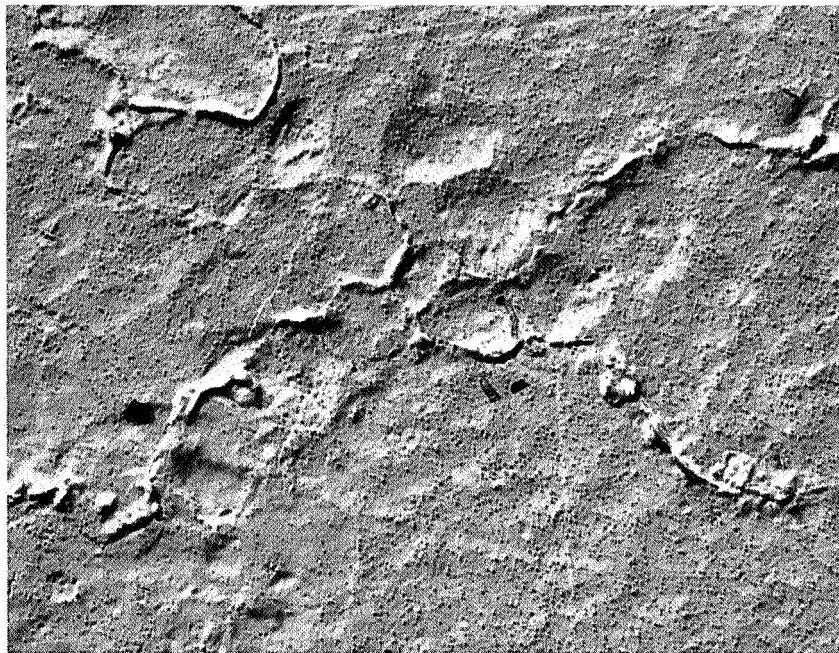
Figure 23: ELECTRON MICROGRAPH (8000X)

The fine-grain structure observed optically is confirmed by electron microscopy. The boundaries appear to contain a precipitate, and small pores are prevalent within the grain (Figures 23 through 25). A Texas Instruments' report interprets various grain boundary surface features as cracks (Ref. 5). The electron micrographs of surface features, as reproduced in that report, do not show enough detail to affirm the presence of cracks. Metallographic profiles will be attempted to determine whether true grains exist as outlined on the surface, and whether cracks exist along the grain boundaries. The "grains" are 4 to 9 microns in diameter and the pores are on the order of 300 angstroms (Å). The pores appear to be thermal etch pits from sintering.

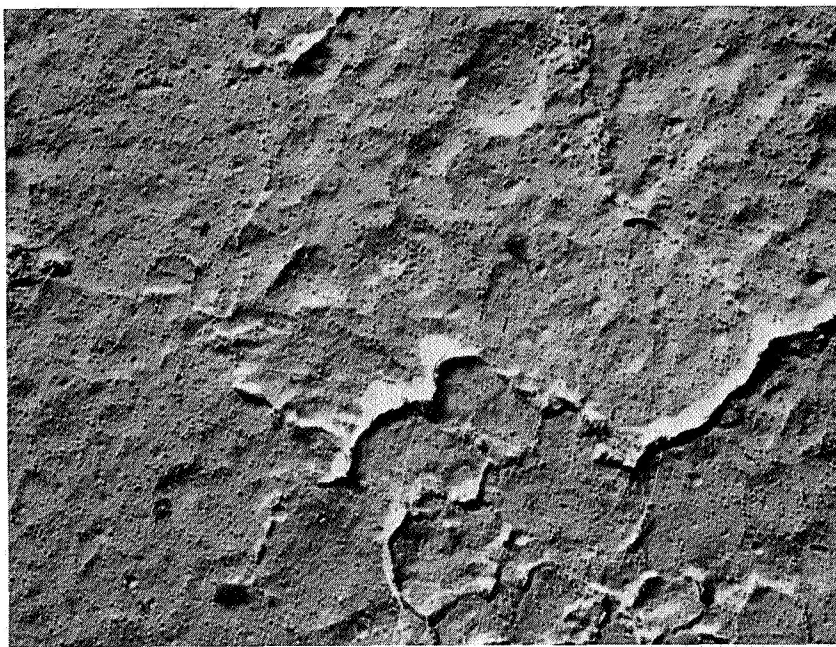
Figure 24: ELECTRON MICROGRAPH (8000X) OF SOLAR CELL SURFACE

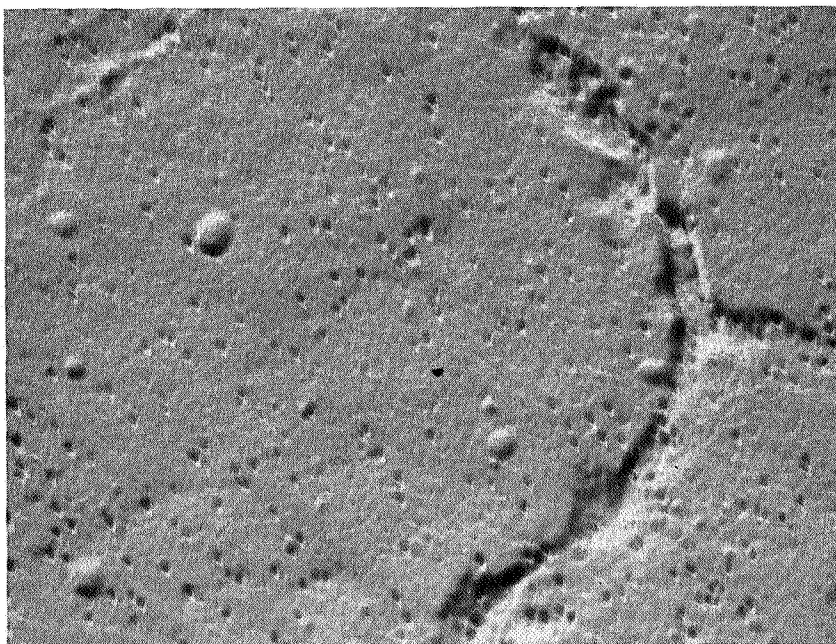
Figure 25: ELECTRON MICROGRAPH (31000X) OF SOLAR CELL SURFACE

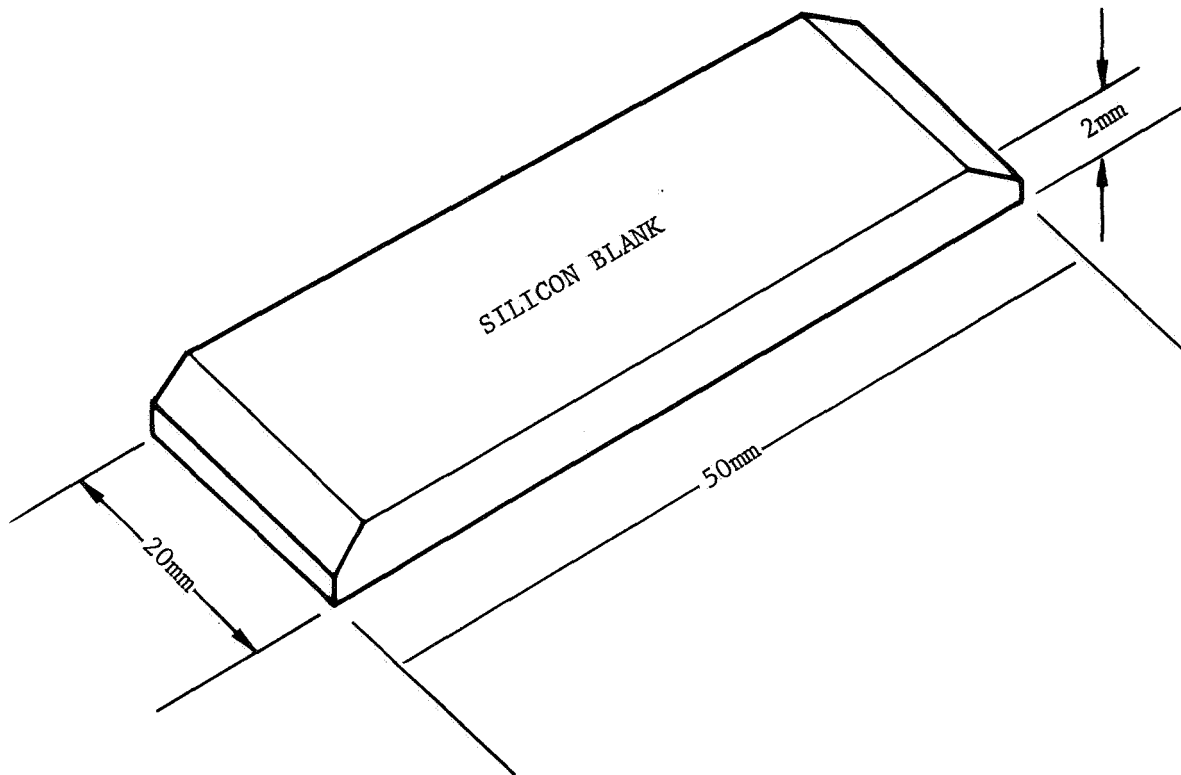
Figure 26: INTERNAL REFLECTION SPECIMEN

Silver-titanium contact corrosion on silicon can be examined by evaporating the desired material on the prism, conditioning the specimen, and measuring adsorption as the corrosion proceeds. Changes in the contact composition can be determined in situ with the use of a liquid sample holder (Figure 28). The depth of penetration of the beam into the contact can be controlled by the wavelength of the radiation and the angle of incidence of the radiation. Specimens have been prepared and the null measurements have been made prior to coating (Figure 29).

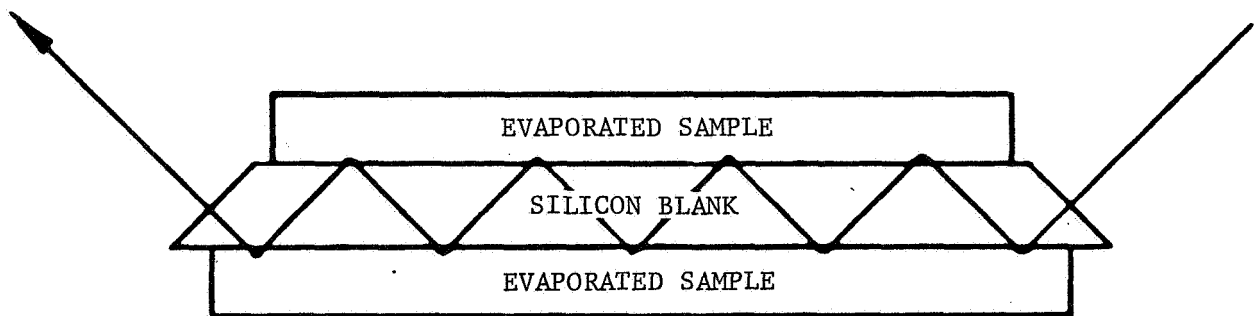
Figure 27: MULTIPLE INTERNAL REFLECTION EFFECT

Internal reflection spectroscopy takes advantages of single-crystal silicon used in the solar cell. The cell becomes a part of a prism and radiation entering the prism is reflected internally for angles of incidence greater than the critical angle (Figures 26 and 27). The beam actually penetrates slightly beyond the reflecting surface into the surface layer on the crystal. Materials on the surface will selectively absorb radiation. A plot of the attenuated radiation versus wavelength becomes an absorption spectrum characteristic of the material.

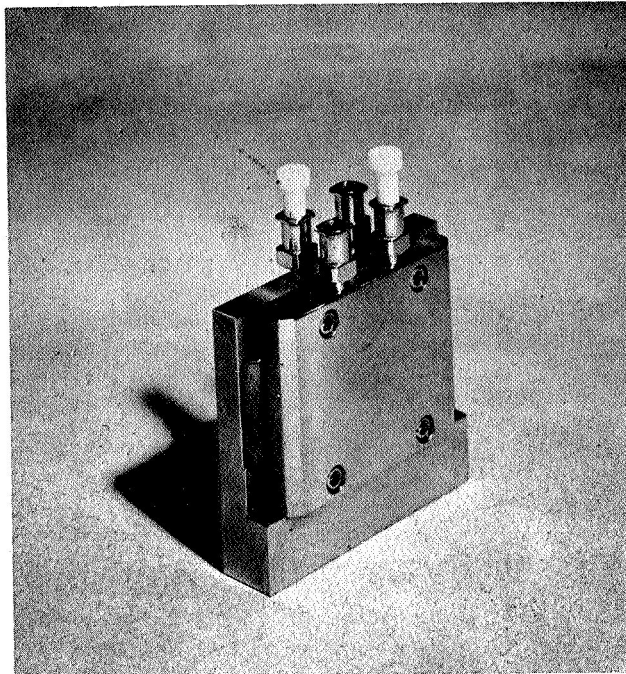
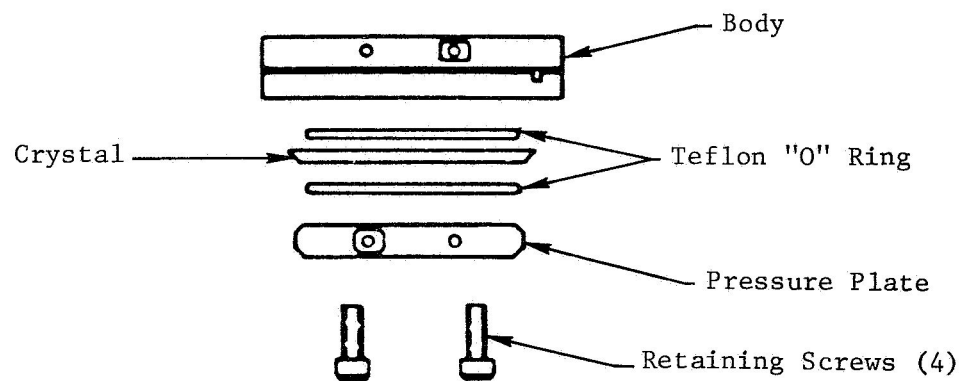
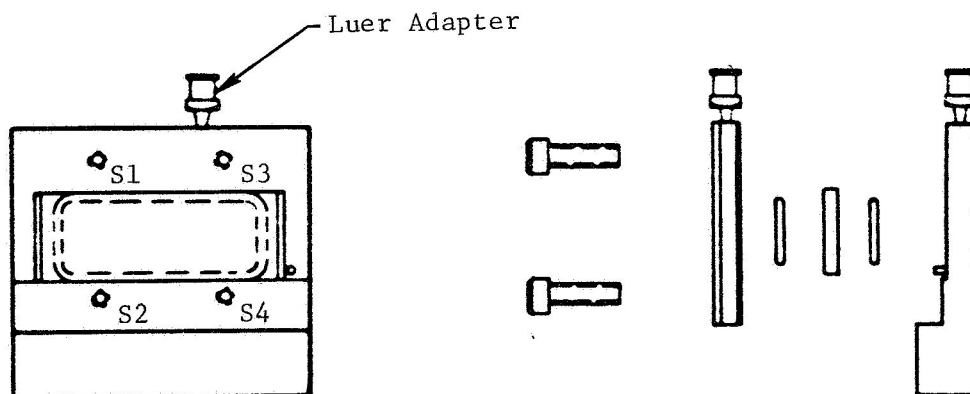
Figure 28: LIQUID SAMPLE HOLDER

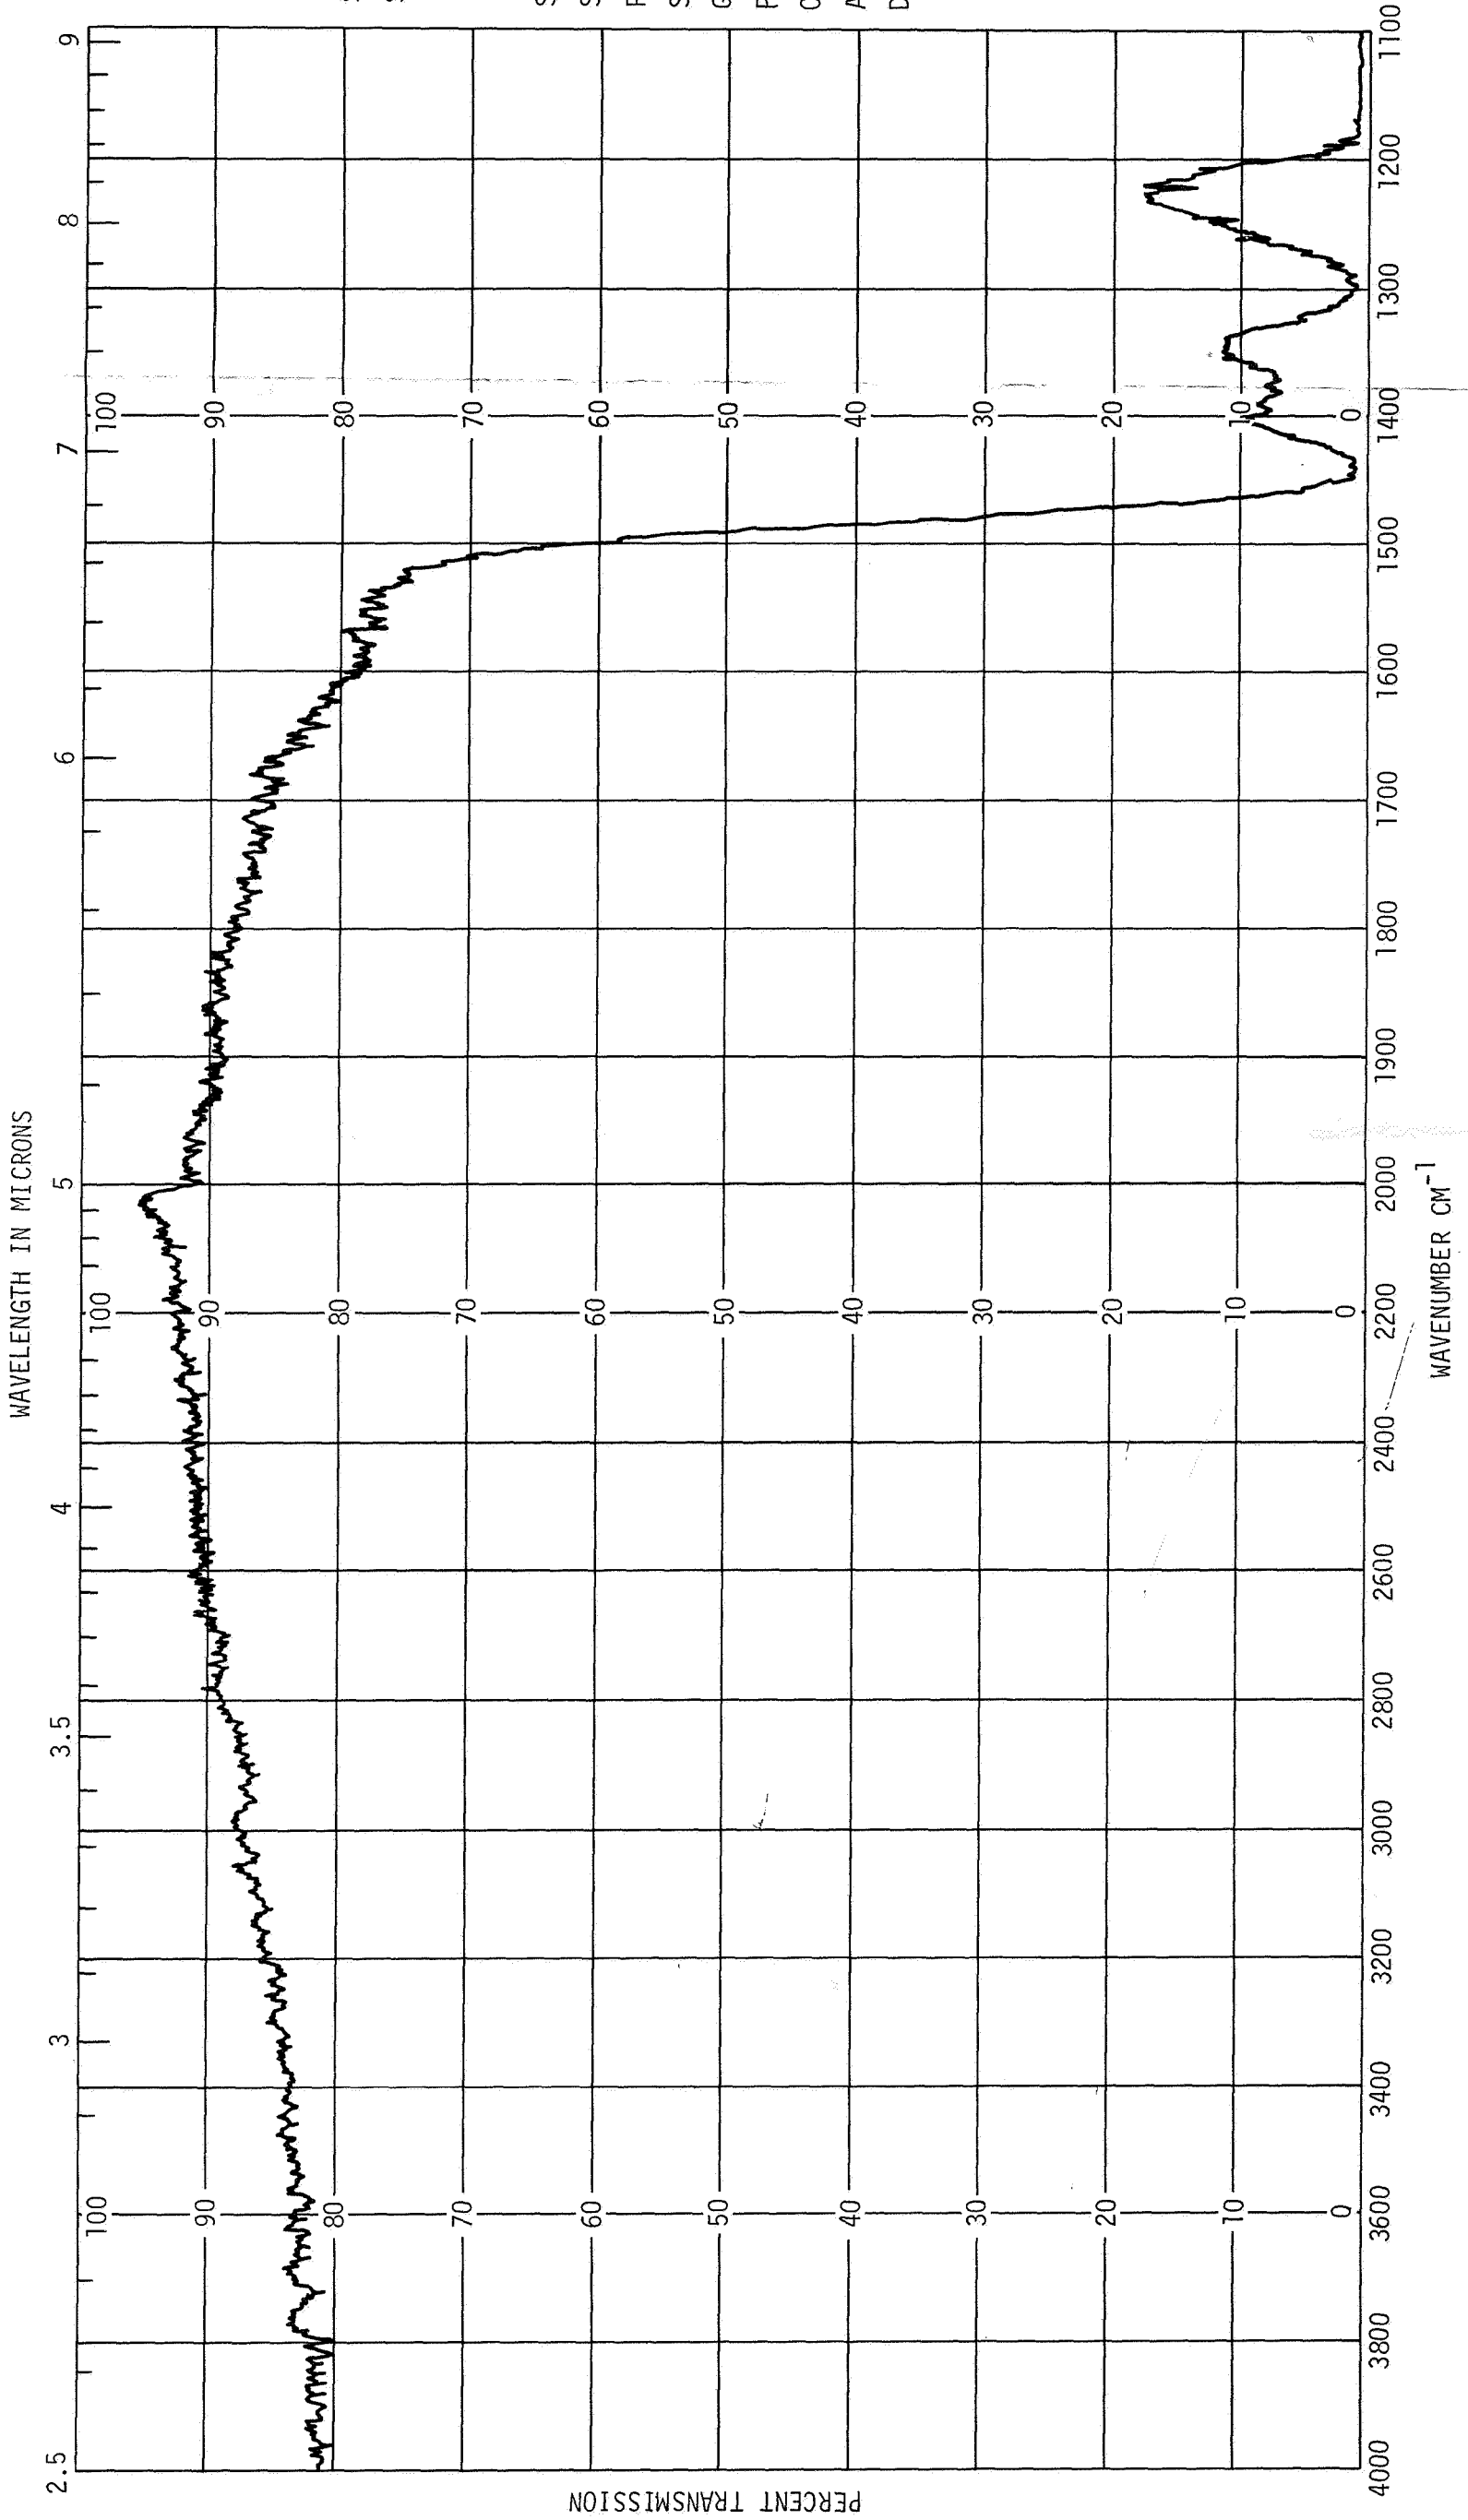
SPECTRUM NO. _____
SAMPLE B
Silicon ATR
Crystal
Blank
SB _____ DB ✓
SB/DB ENERGY RATIO _____
RESOLUTION _____
SPEED 200 out
GAIN 3 %
PERIOD 2
ORDINATE SCALE 0-100
ANALYST DLR
DATE 7/8/69

Figure 29: ADSORPTION SPECTRUM
